CoBI Water Quality and Flow Monitoring Program
Site Evaluation Form
Land Locations

City of Bainbridge Island
Water Quality and Flow Monitoring Program
Site Evaluation Event

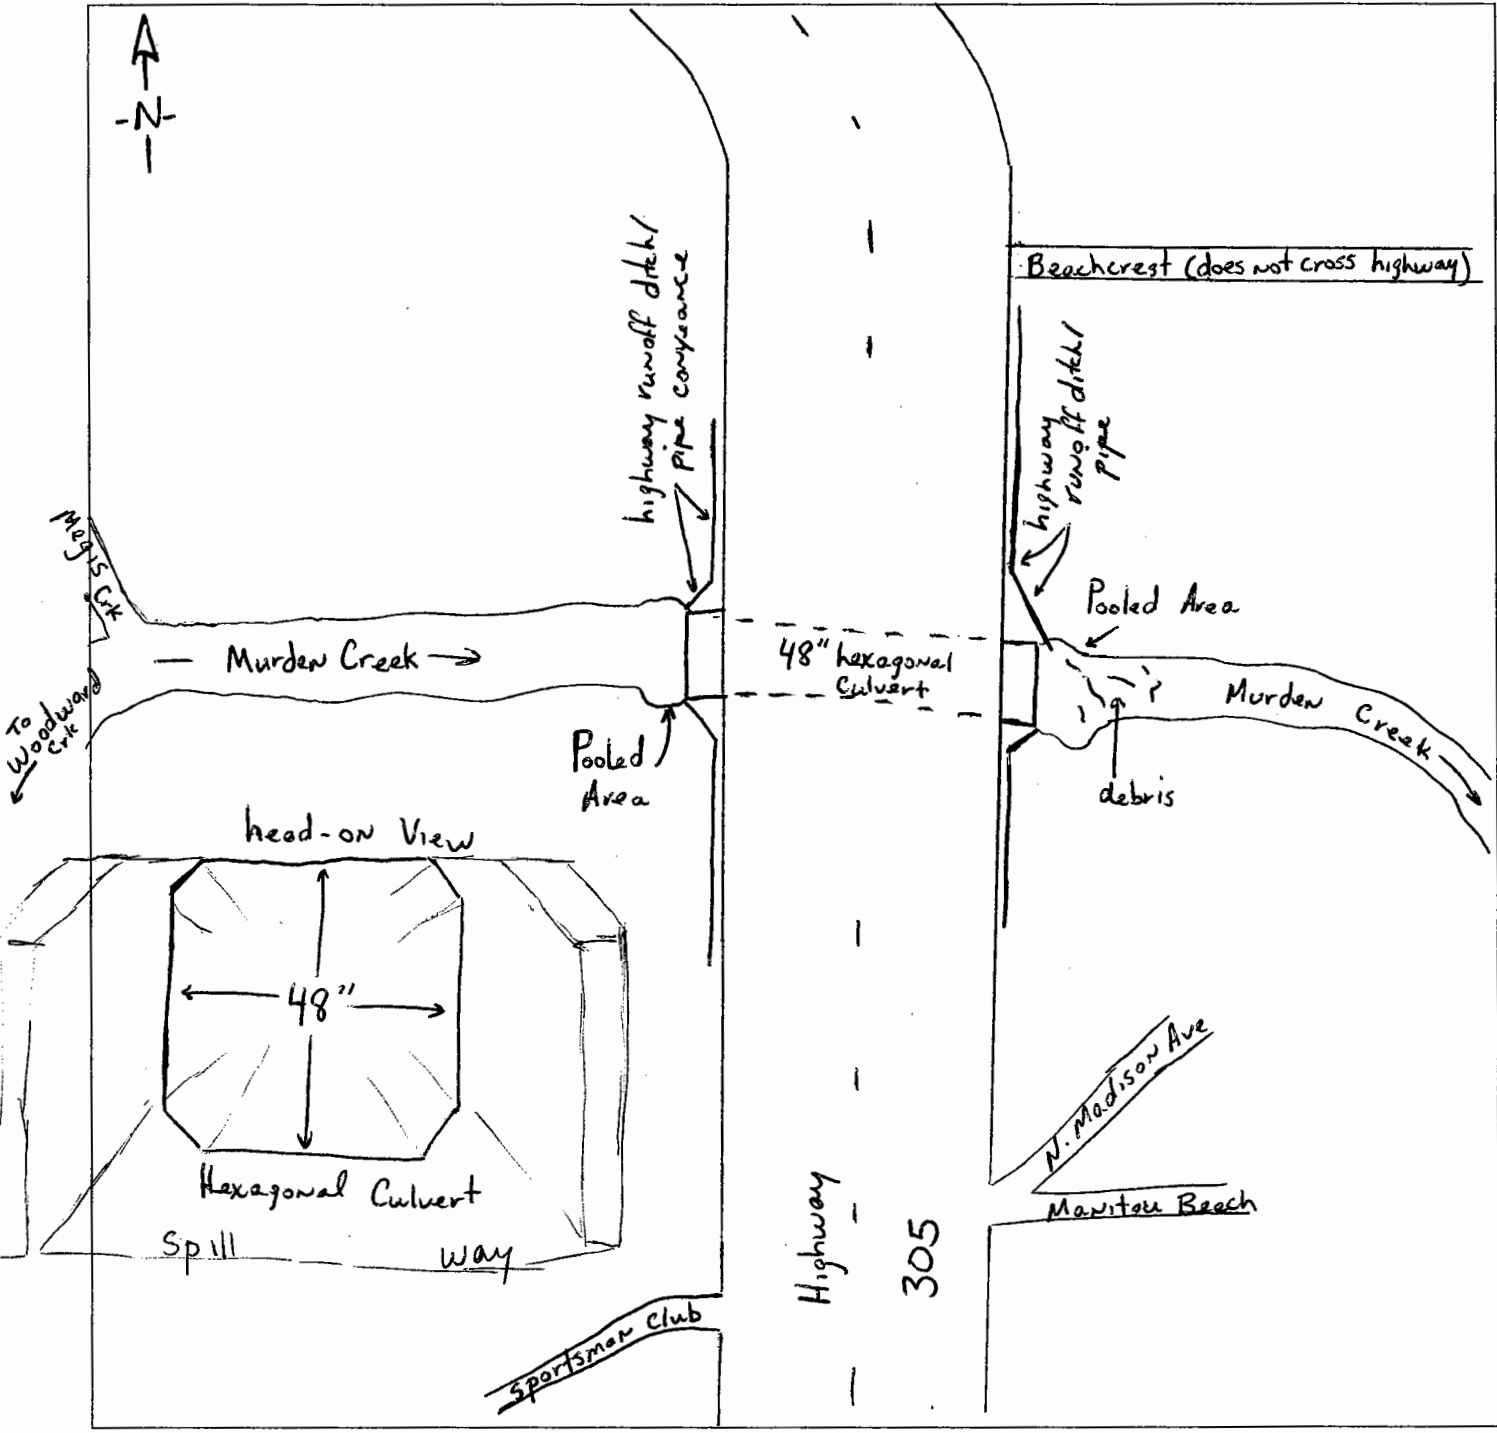
Drawing No. 005
Site Location: SE#16

Channel Type / Description	Flow monitored from either within culvert channel (A-V meter) or from stilling well positioned in deep - main course at either end
Flow Equipment:	A-V meter or level logger / hand measurements
Tidal Influence / Site Effects:	None

Technical Measurements Collected ?	YES ___ NO <input checked="" type="checkbox"/>	If Yes, Report Measurements on Page 3
Site Drawing #:	AA 005	Other Tech. Info. 5'x4' box channel w/ concrete floor

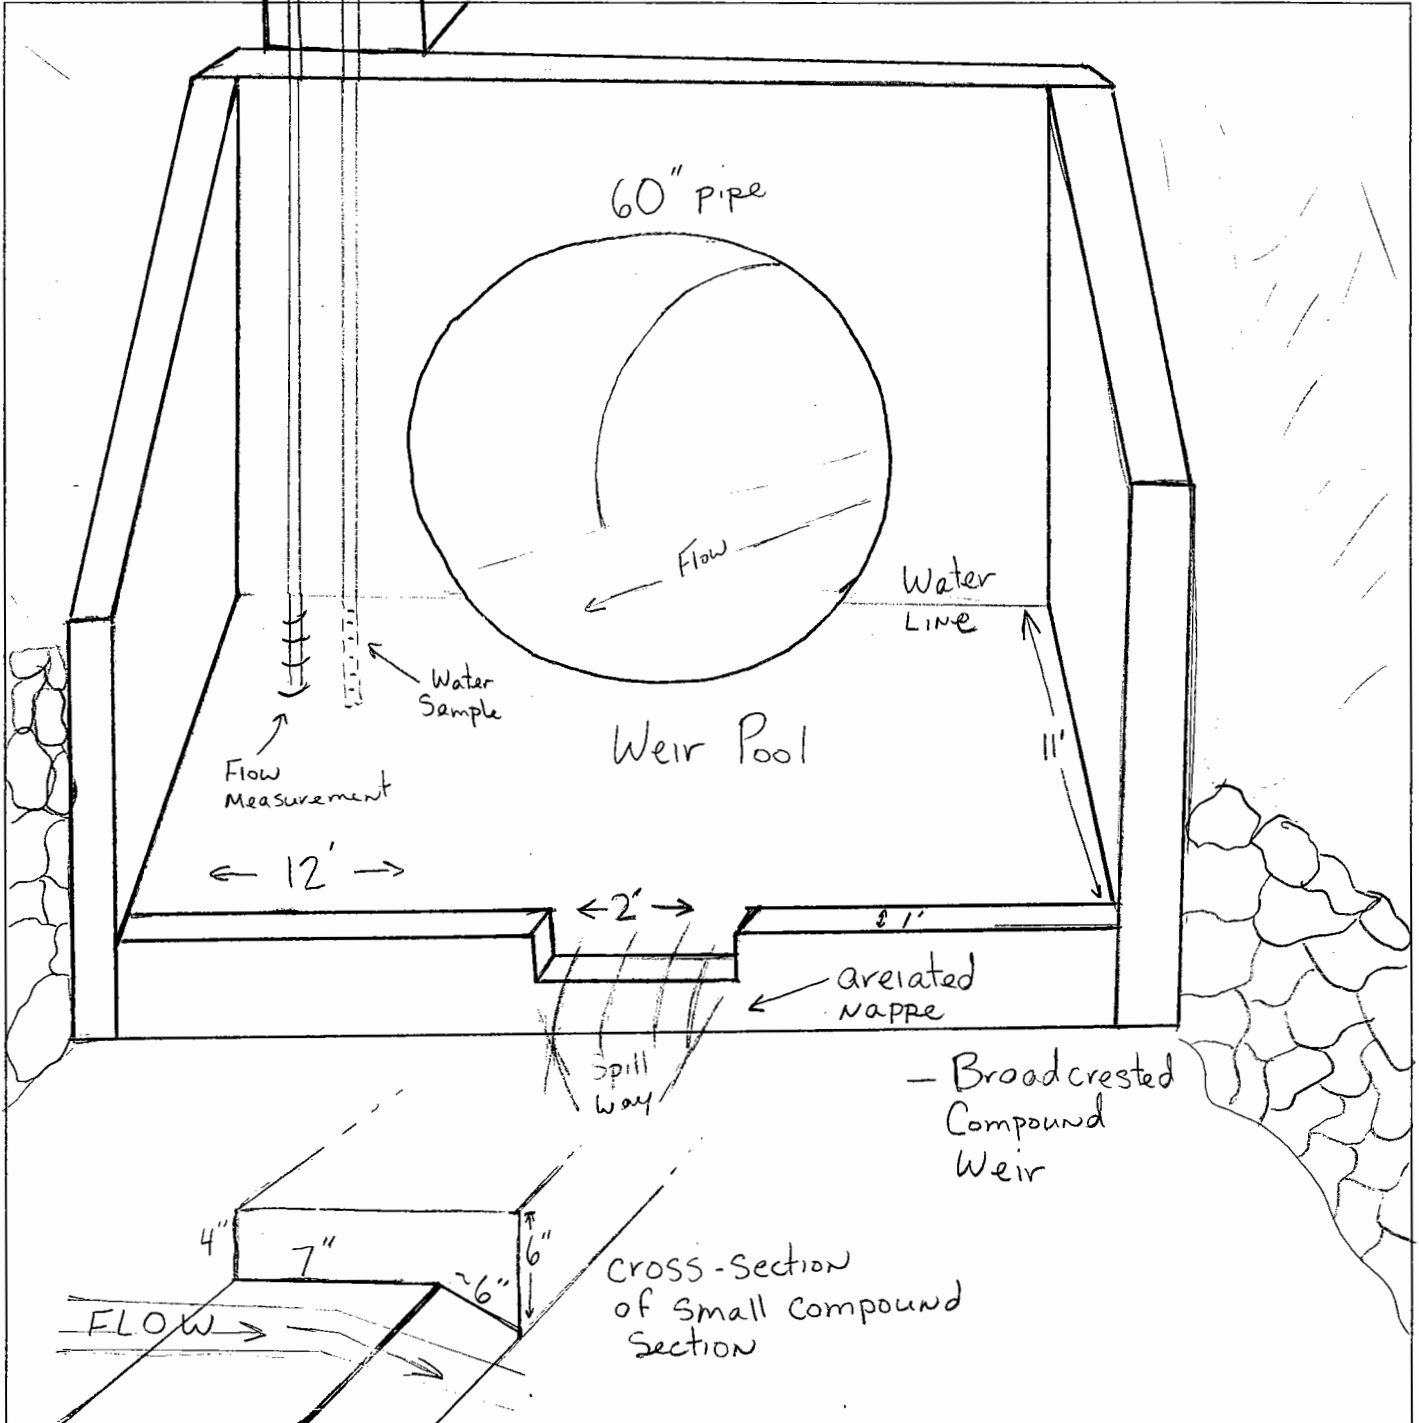
Drawing No. 006

Site Location: SE #35

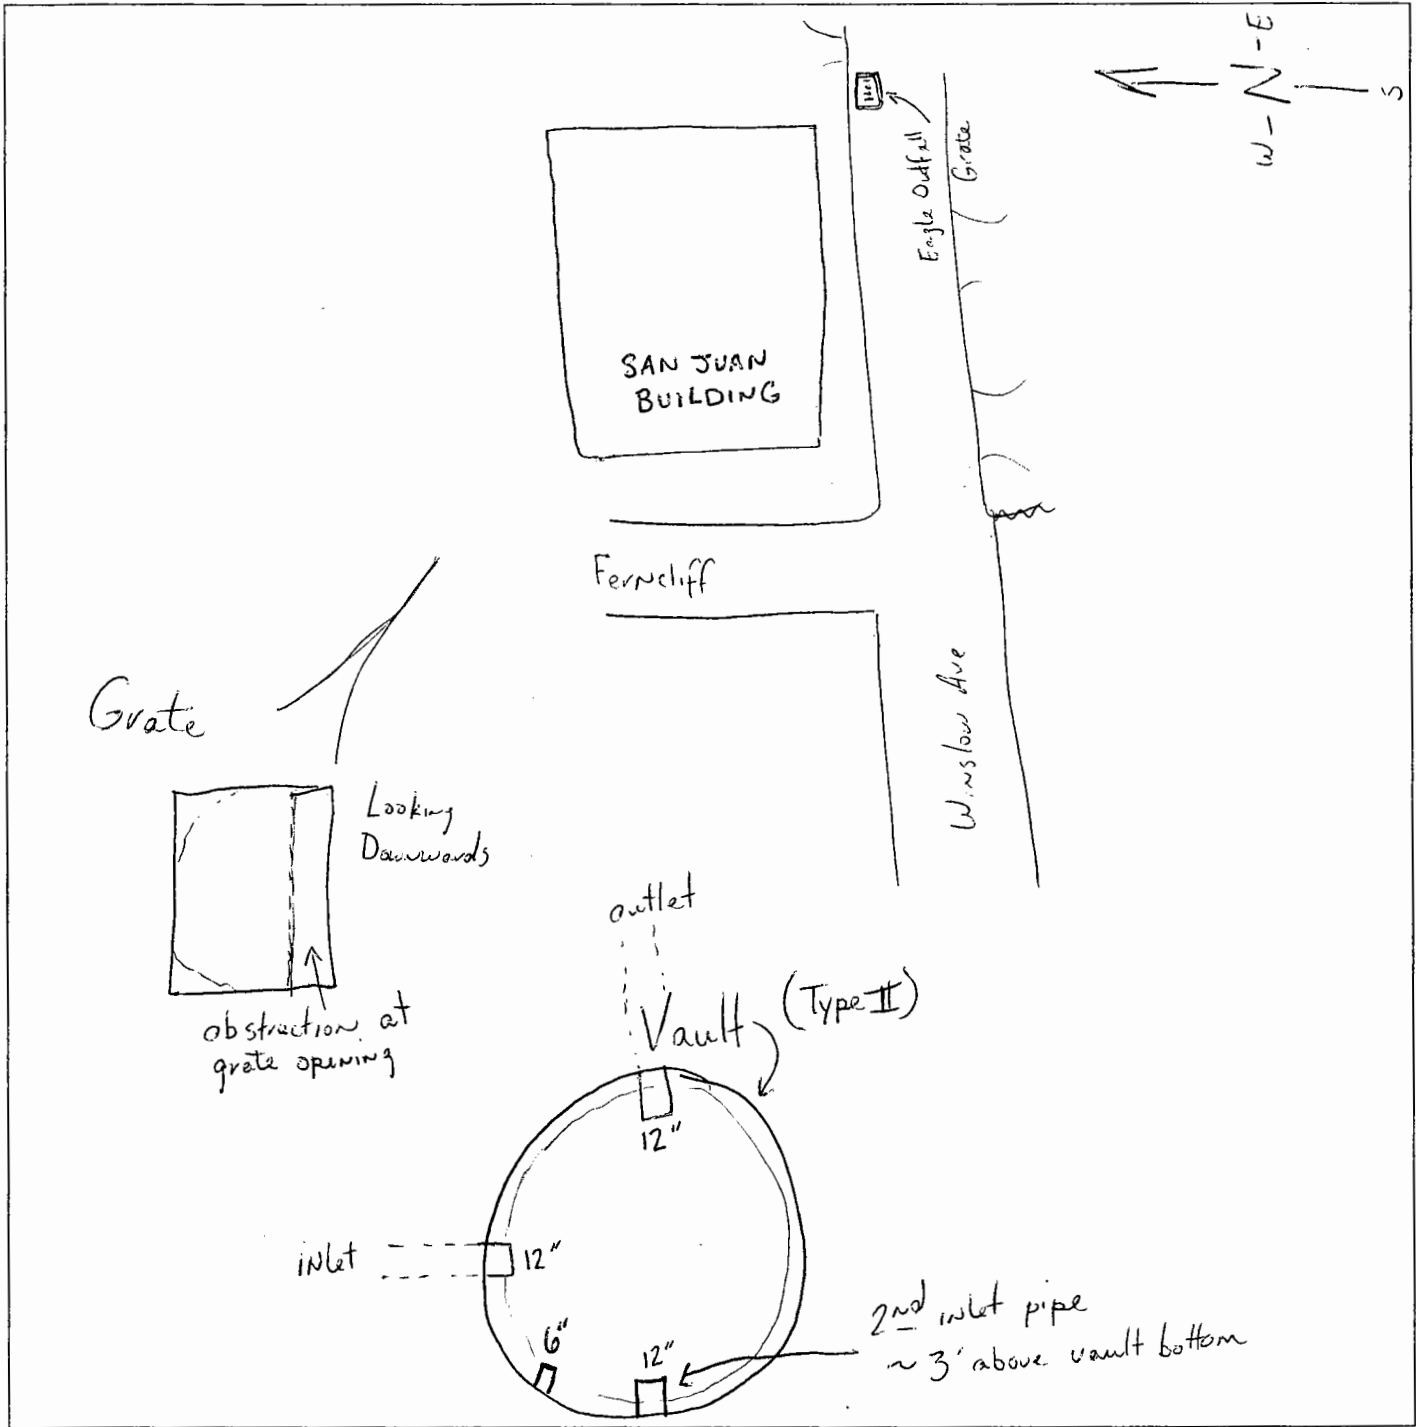
Drawing No. 007

Site Location: SE # 66 Eagle Outfall
